Evaluation Report Part A:

Urgent Stonework Repairs at Great Malvern Priory during 2019

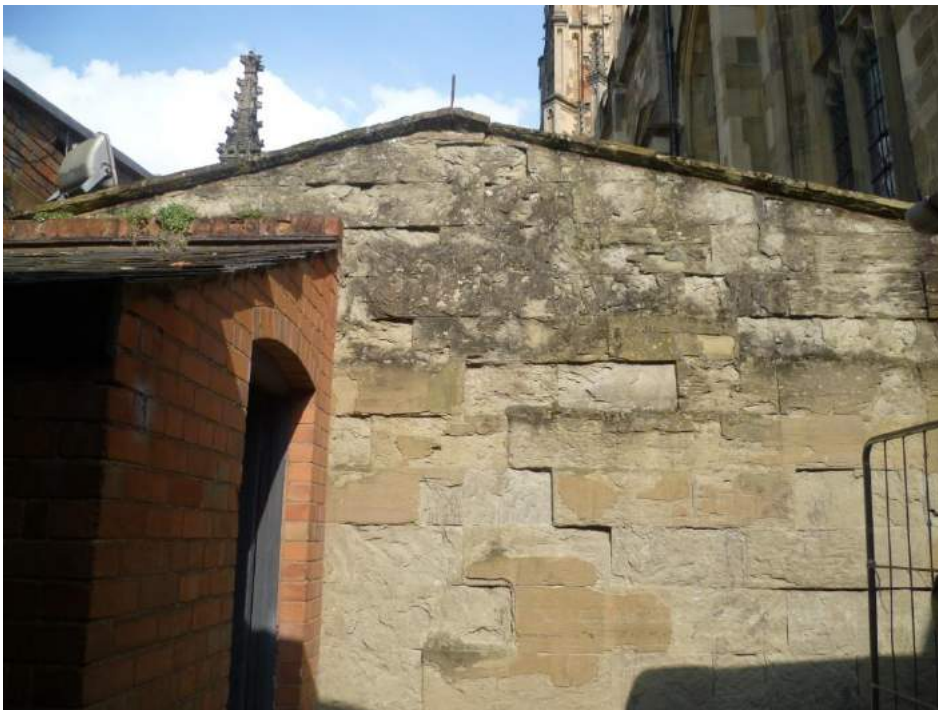
Figure 2 shows the wall before dismantling. Drill tests in 2013 [3] showed that the wall comprised an inner brick skin with an outer stone cladding, and that the stone cladding was not tied into the brick skin and was bowing with a gap of typically 10cms between the cladding and the brick skin. The coping stones required pointing and the stone at the apex was cracked. Furthermore, the brickwork above the aisle roof and visible from the east side were in a very poor state and also needed to be taken down and rebuilt.

Figure 2: Section of the West Wall to be rebuilt

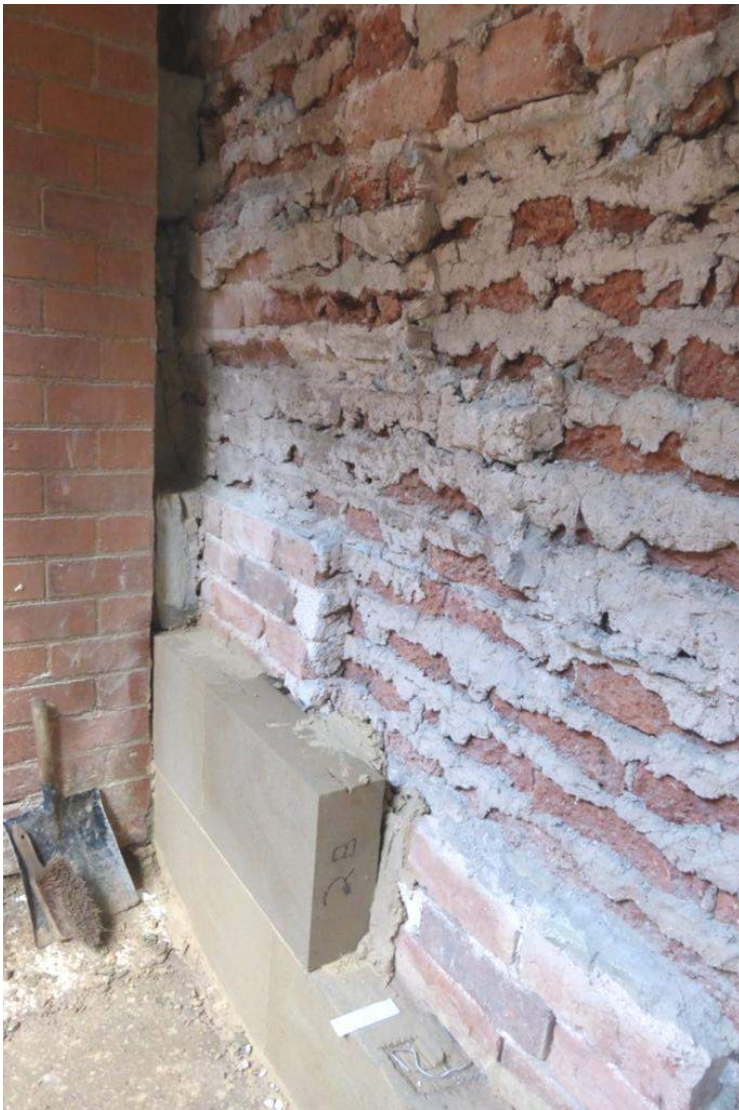
As the old stone was removed it became apparent that the bricks of the inner skin had been cut back to a width of only around 5cms as shown in figure 3.

*Figure 3: West Wall with stone cladding removed
(Note new stone courses in place at base)*

The wall was then inspected by the Priory's structural engineer (FW Haywood) who provided a report [5]. He, together with the Priory surveyor and the DAC, all agreed that since the inner brick skin had remained true for more than 100 years, it could remain in place provided the new outer stone wall was tied into it and that any space between was grouted. Alternate courses were either tied together with s/steel cramps or tied into the mortar of the brickwork.

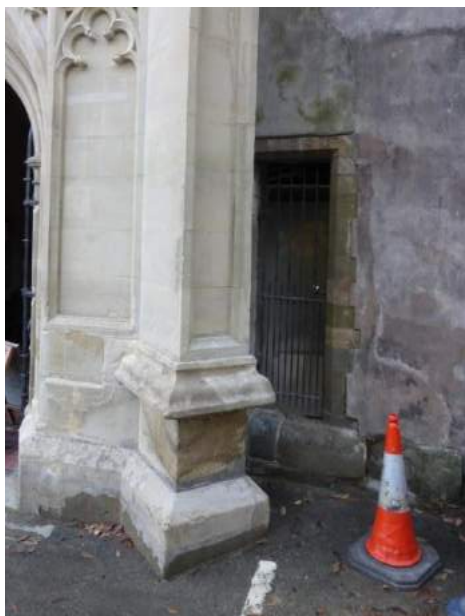
It was a requirement of the Faculty that the foundations of the wall be inspected. Old drawings and prints show a bank rising steeply from the foot of the West Wall. At some time later (possibly in the 1840s when the Abbey Hotel was built?), the ground was banked up to raise the level between the hotel and the Priory. To keep the earth away from the West Wall, a retaining wall was built approximately 70 – 100 cms away from the West Wall and arched over to the West Wall to form a tunnel that runs the whole width of the Priory. Figure 4 shows the entrance to the tunnel. In recent times two toilets have been formed in the space of this tunnel with an entrance through the west wall of the Porch.

Figure 4: Entrance to tunnel running behind the west wall of the Priory

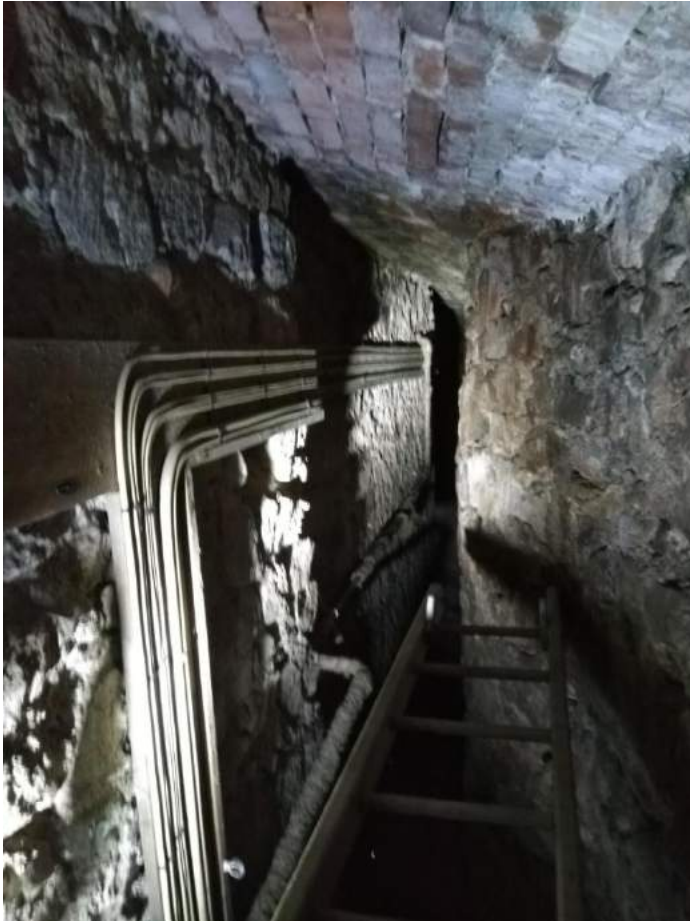
found both the Priory and retaining walls to be in good condition [5]. Figure 5 shows the interior of the tunnel. Note the presence of cables and water pipes.

Figure 5: Interior of tunnel at north end (beyond the toilets)

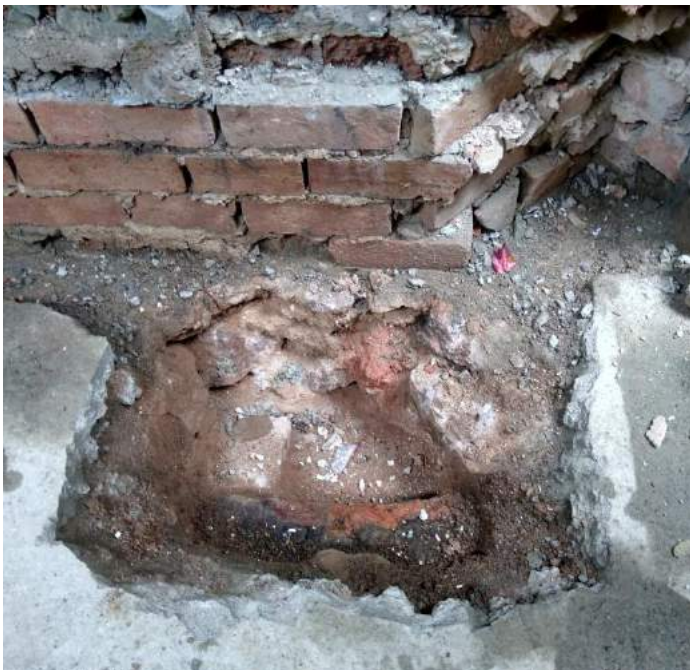
To judge the distance between the top of the tunnel and the level between the Priory and the hotel, a small pit was dug as shown in figure 6. This distance was only of order 25-30cms.

Figure 6: Trial hole dug below the level of the West Wall visible from Abbey Hotel exposing brickwork in the roof of the tunnel below

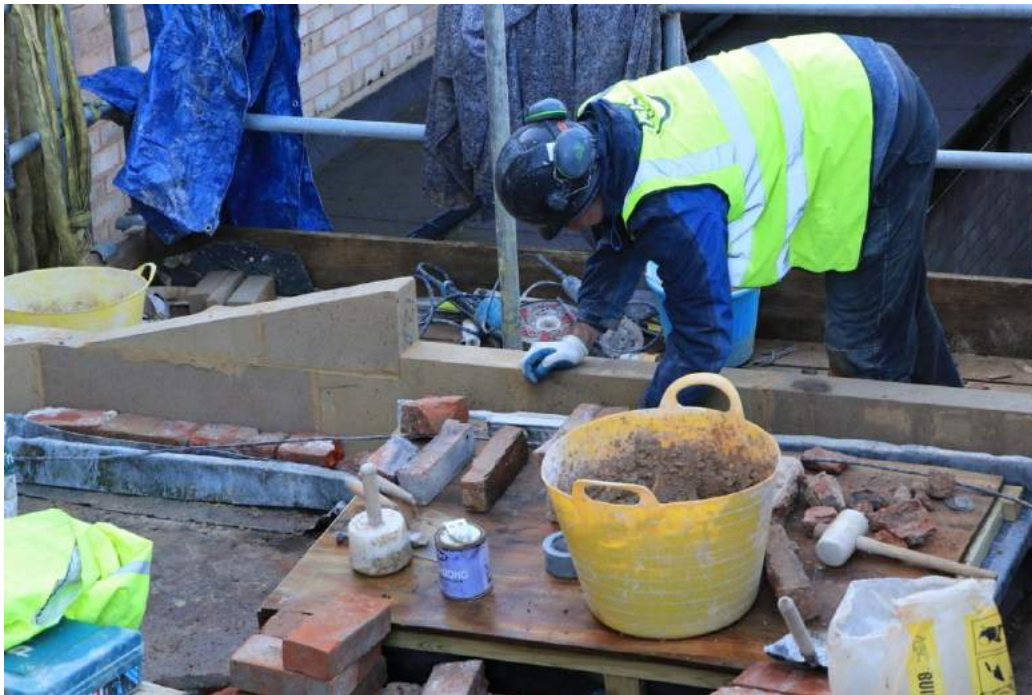
Figure 7: Rebuilding the gable of the West Wall and its brick face (viewed from the aisle roof)

The wall was then rebuilt with new stones, new brickwork on the east face of the gable and with new or cleaned copings as shown in figures 7 and 8.

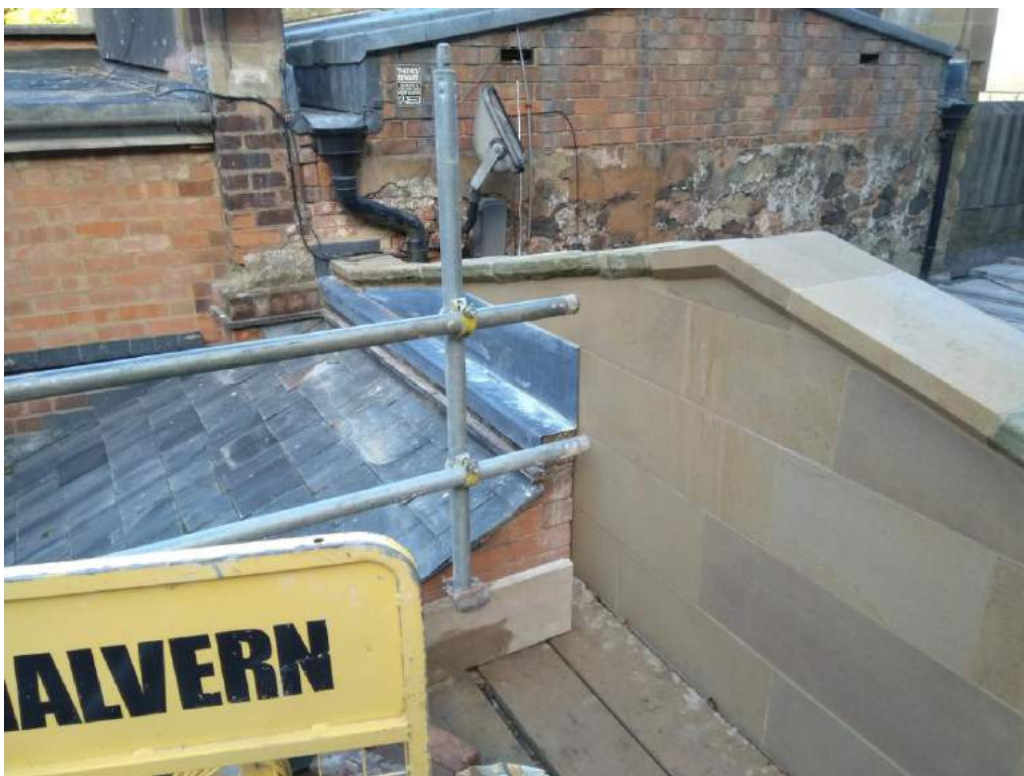
Figure 8: The completed gable of the wall viewed from the hotel side. Note the new flashing above the 'lean-to' shown in figure 2

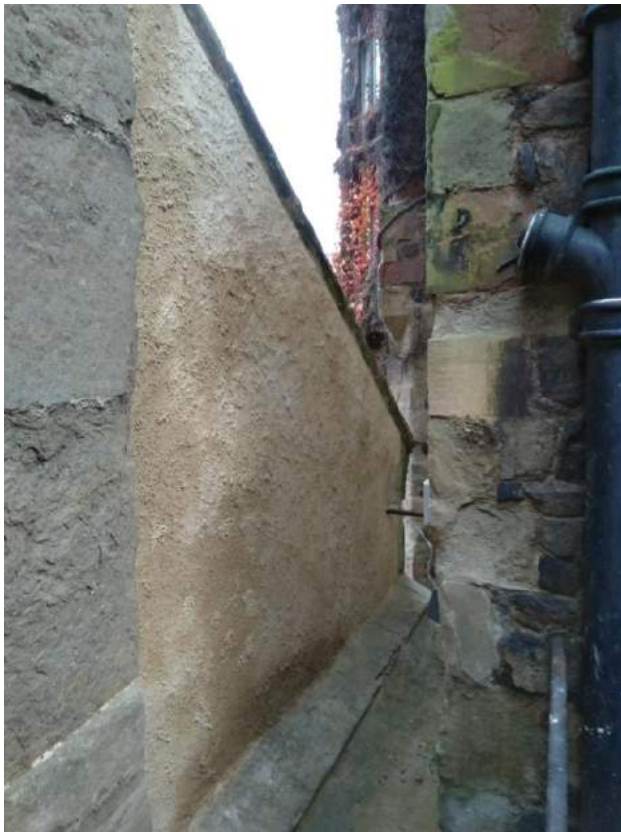
Figure 9: Completed lime roughcast render applied to S Aisle West Wall

To help preserve the delaminating stone forming the wall at the west end of the South Aisle, a render was applied with a horse-hair base coat. Figure 9 shows the render completed.

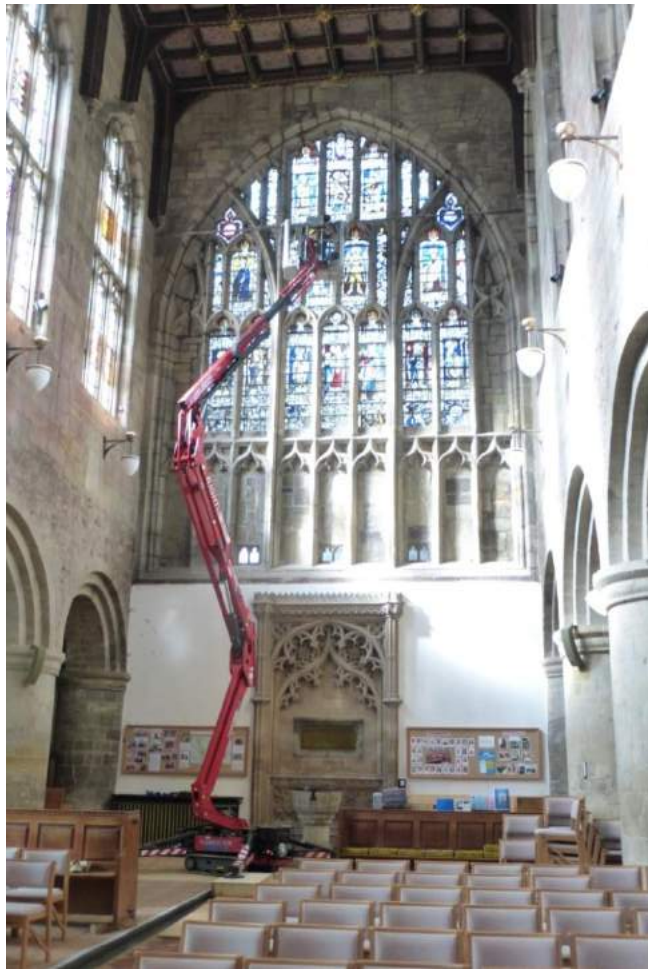
Internal cracks in the north and south clerestory walls at the west end and at the east end of St Anne's Chapel (the chancel south aisle) were inspected by FW Haywood, the Priory's structural engineer, in 2018. His report [4] indicated that the cracks were not structurally significant but should be pointed with a flexible mortar to prevent small pieces of stone and grit getting inside that would prevent the cracks closing as the building moves.

Figure 10: 'Cherry Picker' used to repoint cracks in clerestory walls.

The cracks in the clerestory were pointed with the aid of a cherry picker, shown elevated in figure 10.

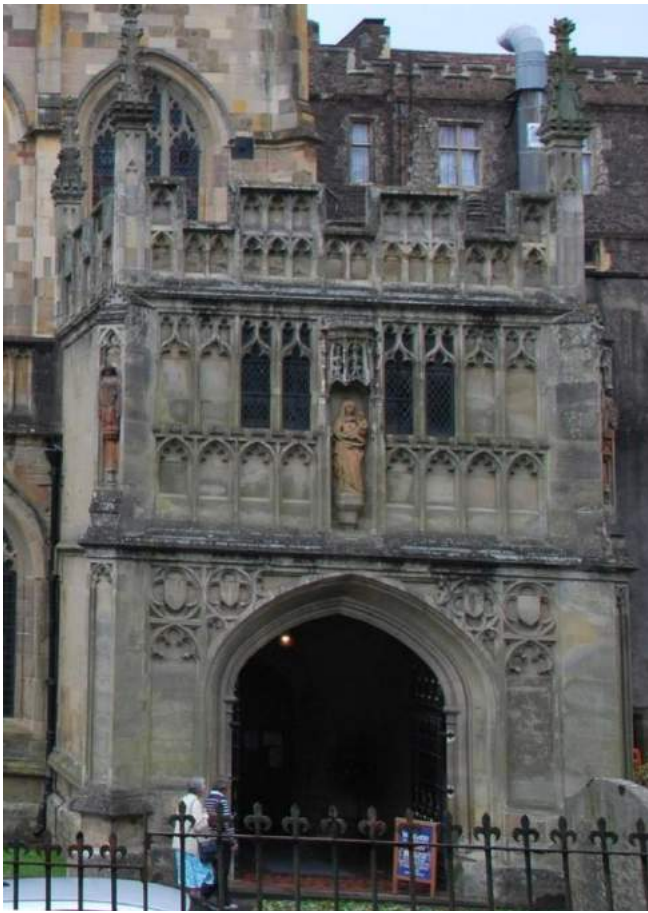
Figure 11 shows the Porch before work started. It is the most decorative element of the Priory but its dirty condition set a 'down-at-heel' tone to the building. The pinnacles and carved detail around the parapet were heavily blackened with carbon deposits. A detailed survey in 2016 [6] stated that the pinnacles needed stabilising within 2 years. It explained also that the carved detail was losing form and legibility as shown in figure 12.

Figure 11. North Porch before work commenced.

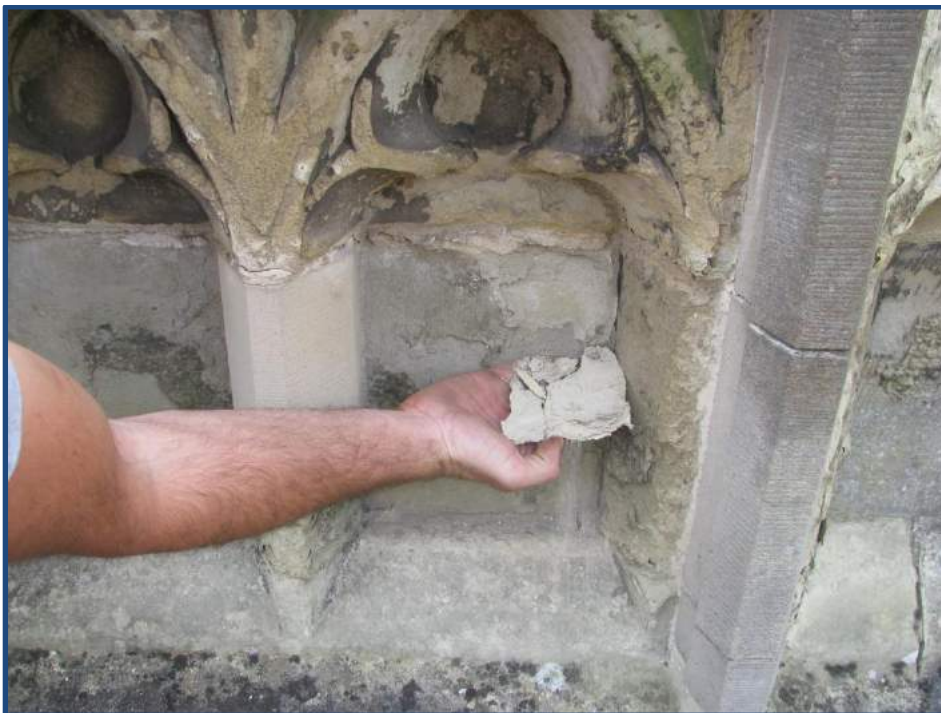
Figure 12: Dirty and decaying stone in the parapet.

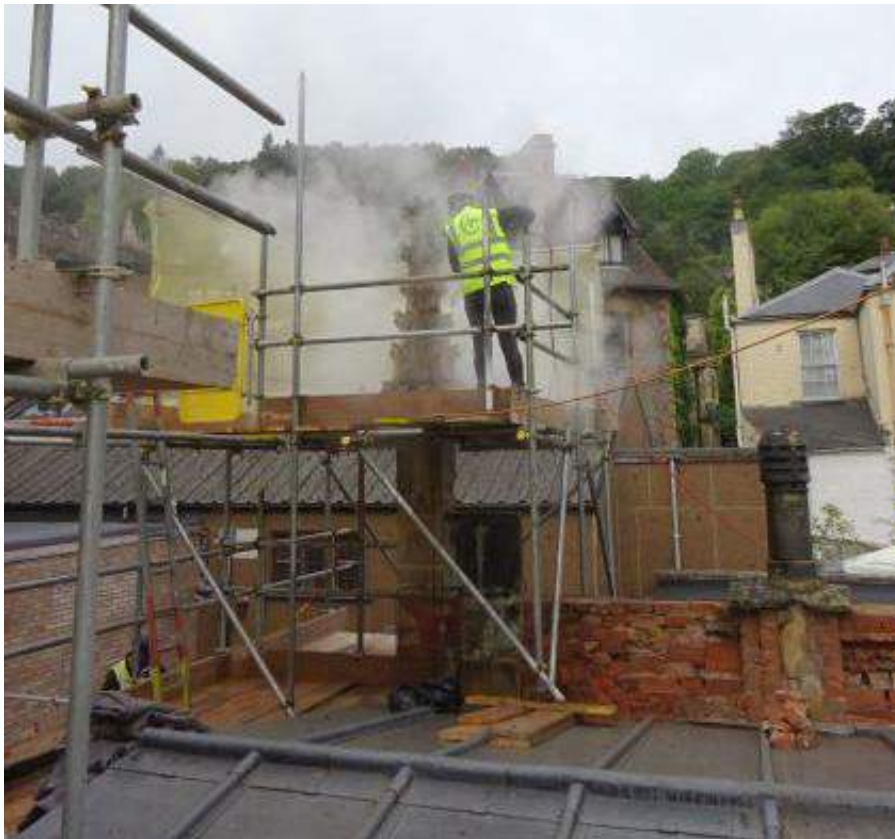
Figure 13: Stone being steam-cleaned with a ThermoTech machine.

The stone was first steam-cleaned using a ThermoTech machine. Figure 13 shows the SW pinnacle being cleaned in this way.

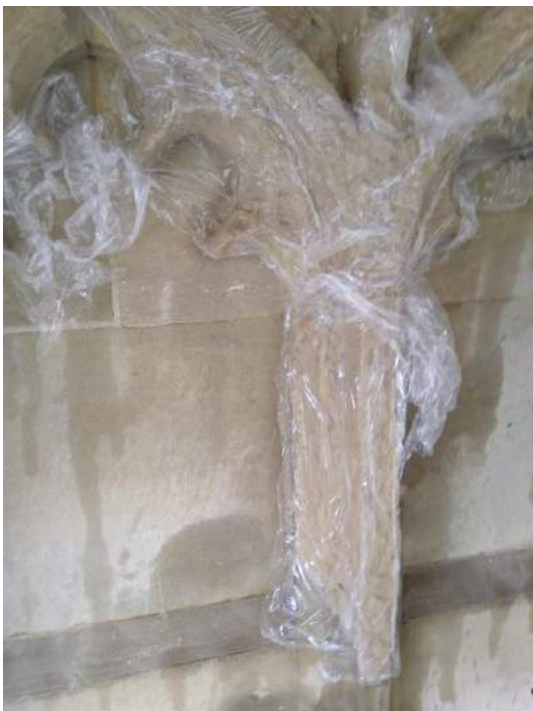
Figure 14: Ammonium carbonate poultice applied to clean carved detail.

Some areas of carved detail were then cleaned further by applying an ammonium carbonate poultice, covering this with cling film for several hours as shown in figure 14, and then carefully washing the poultice off.

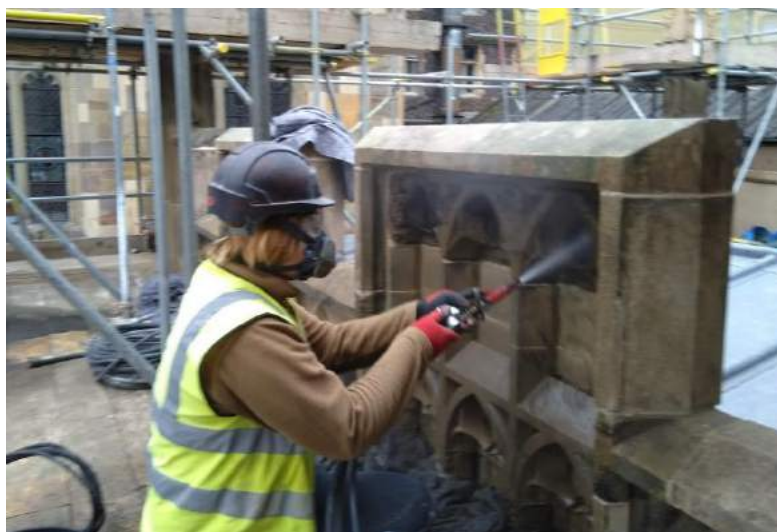
Figure 15: The VorTech machine being used to clean the stone.

The carbon deposits on parts of the stonework were too thick to be removed by poulticing and a VorTech machine was then used as shown in figure 15. This projects a swirling jet of water containing abrasive particles at the stone and was successful in removing the carbon or reducing it to a lighter grey colour.

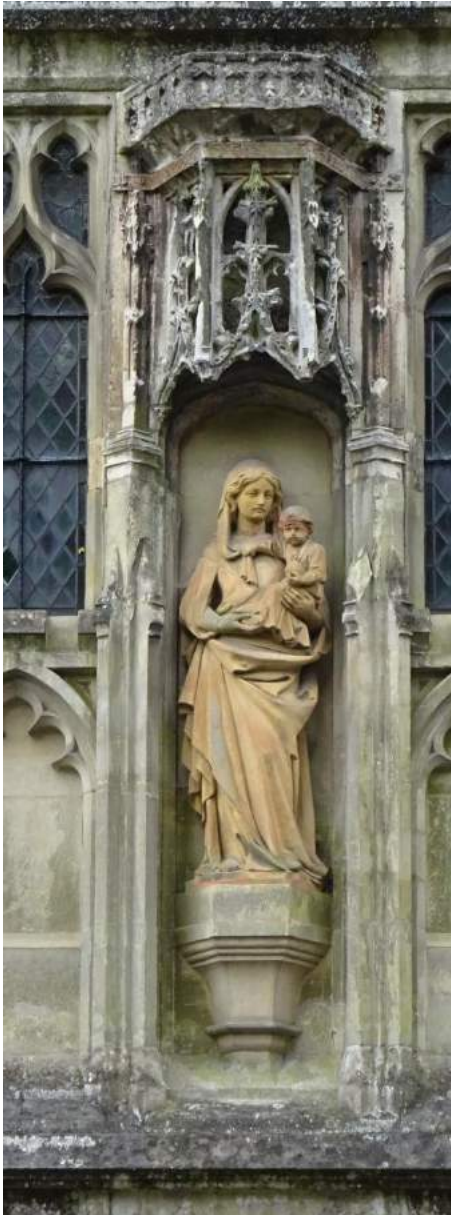
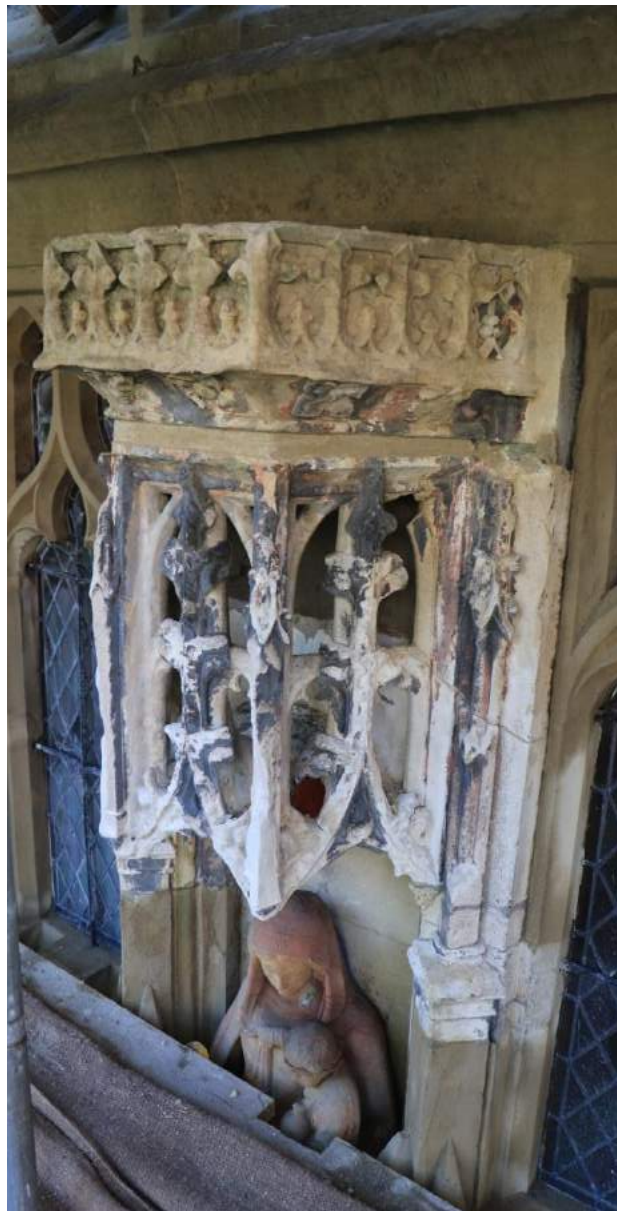
The masons were excited to discover the highly elaborate carving of the canopy above the statue of the Virgin and child. It is shown in figure 16. (It had been so covered in black deposits that it had been hard to discern.) Traces of historic red paint can be seen on the carving. A sample of this paint was sent for analysis together with other paint samples from the statue and elsewhere on the porch. The analysis report is included as Appendix 1.

Figure 16: The Canopy before and after steam cleaning.

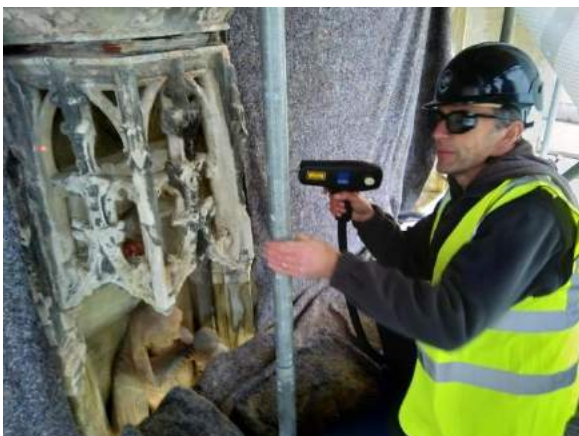
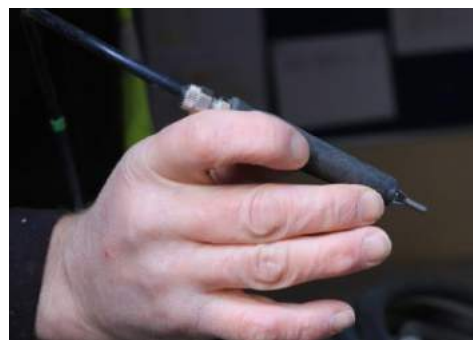
Figure 17: Laser and micro-air abrasive cleaning jet.

The carbon deposits on the canopy had obscured the detail of its carving. To clean this, a trial with a laser was conducted. This proved effective, but it also removed the paint and was slow and relatively expensive. A ‘micro-air’ abrasive machine was then used. This is depicted in figure 17. It projects a fine jet of air with abrasive particles at the stone. This succeeded in either removing or thinning the carbon deposits so that they could be removed with a scalpel.

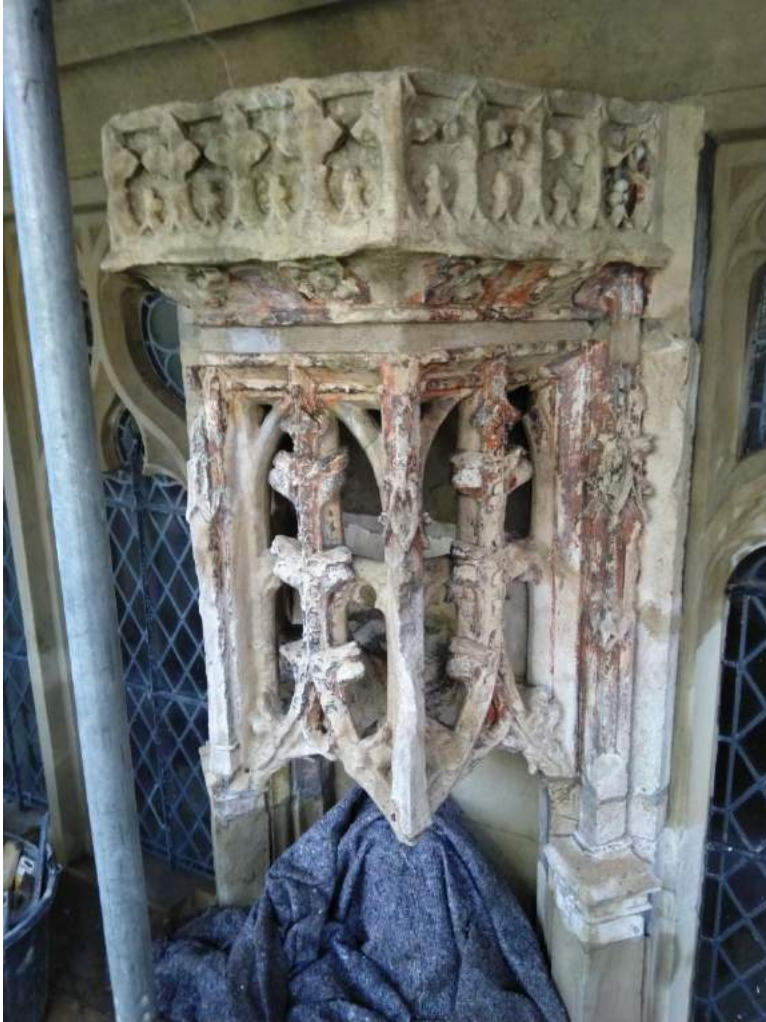
The cleaned canopy showing the red paint is depicted in figure 18. Because of the whiteness of its stone and the highly ornate carved detail, SSHC believe that the canopy is carved from high quality white Normandy limestone. From similar carvings they have seen elsewhere they believe it may date from the early 1500s. Due to the presence of the paint, and because the carved detail has remained so legible, there is speculation that it may have been taken at some point from an internal location in the Priory or from another building. However, records of a PCC meeting in August 1895 following the restoration of the Porch in that year show that the carved canopy stone was retained during the restoration. Further, a drawing of the N Porch by JM Turner (which probably dates from the early 1800s given that Turner died in 1851) shows the canopy in place.

Figure 18: The canopy after removal of carbon deposits showing red paint

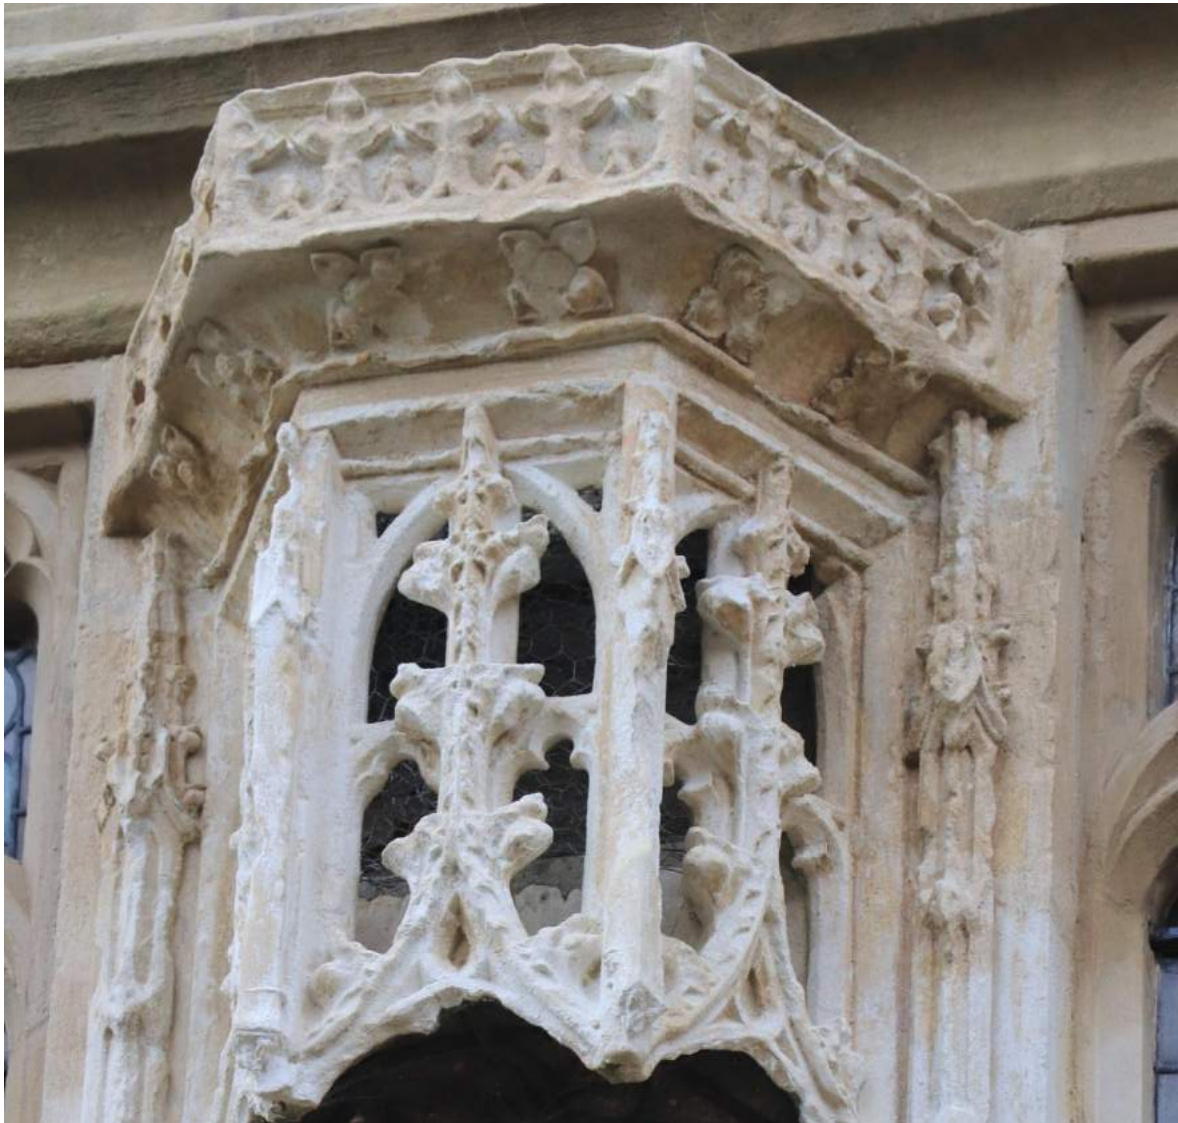
Figure 19: The cleaned and restored canopy after application of sheltercoat.

In order to preserve the paint, it was stabilised and covered with a sacrificial layer of lime-based sheltercoat. The result is shown in figure 19.

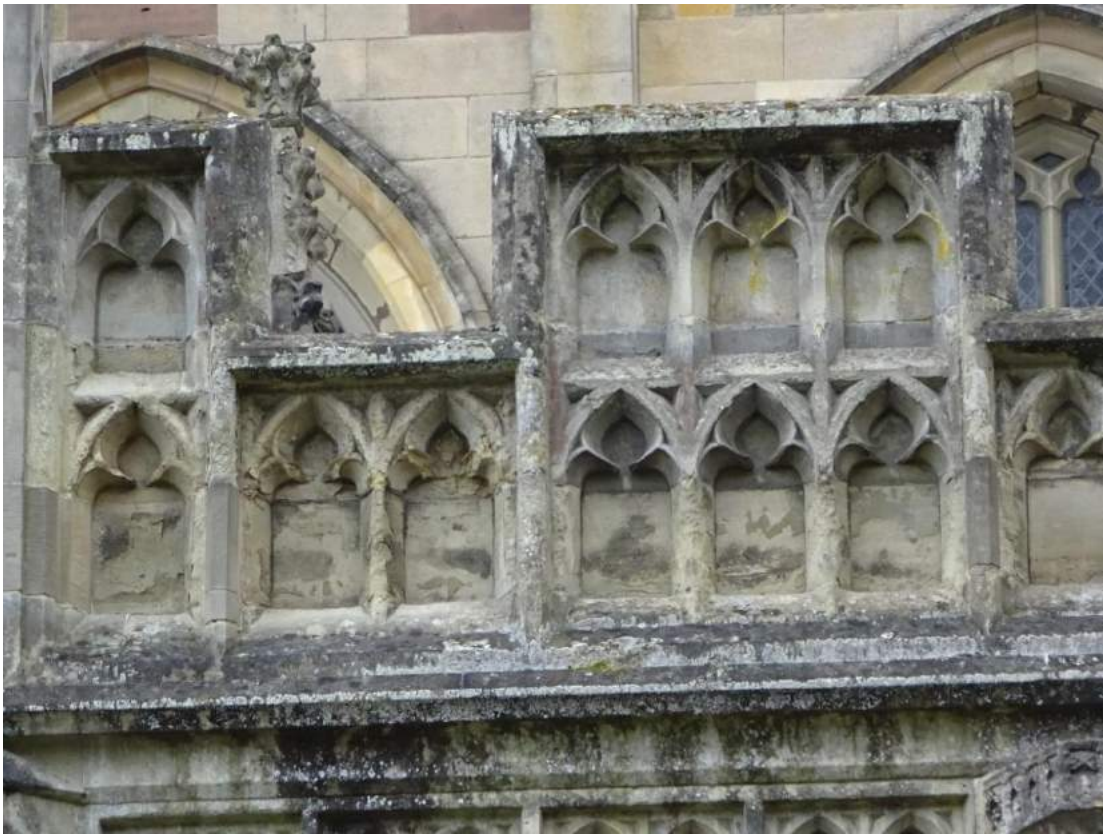
The original condition of the parapet is shown in figures 11, 12, and 20 below. In figure 20 note the black deposits on sky-facing surfaces, the eroded state of some of the mullions and the eroded cusps of the carved detail. Figure 21 shows the parapet being repaired: new stone mullions have been pieced in and lime mortar has been applied and is being pared back to the required forms. Figure 22 shows a lower section of the parapet. A lime-based sheltercoat has been applied (at this point still wet) to bind the stone.

Figure 20: Original Condition of the parapet

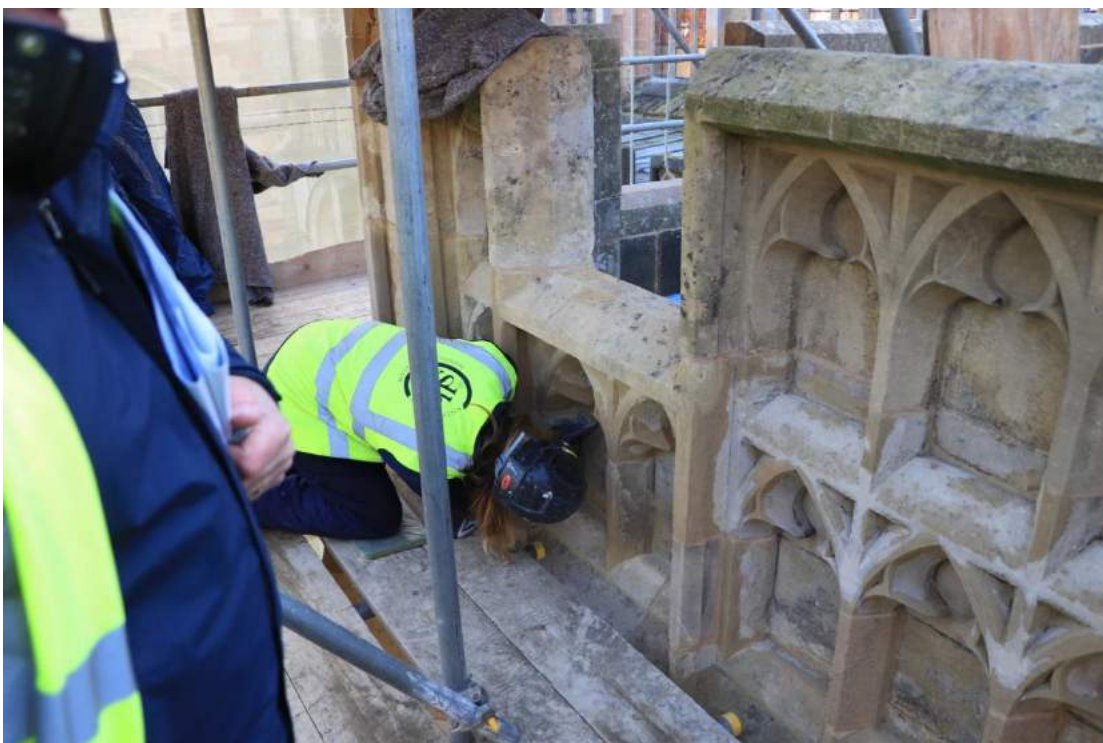
Figure 21: The section of the parapet shown in figure 20 undergoing repairs.

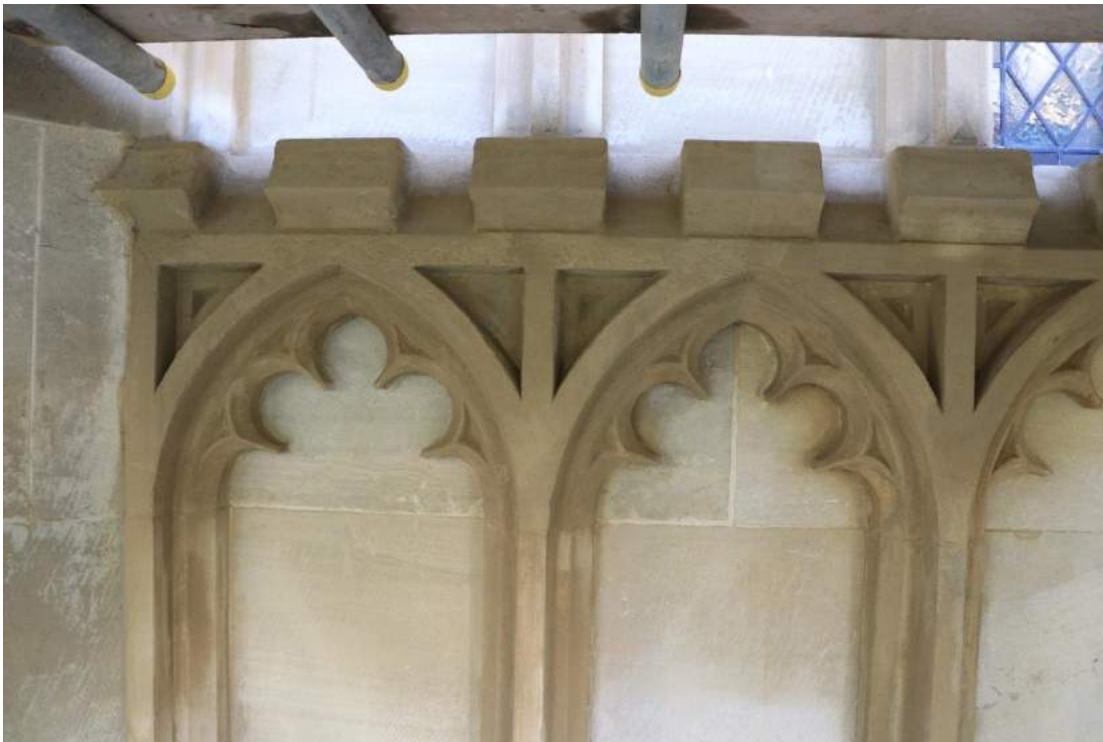
Figure 22: Sheltercoat (still wet) applied to a section of the parapet after cleaning and repair

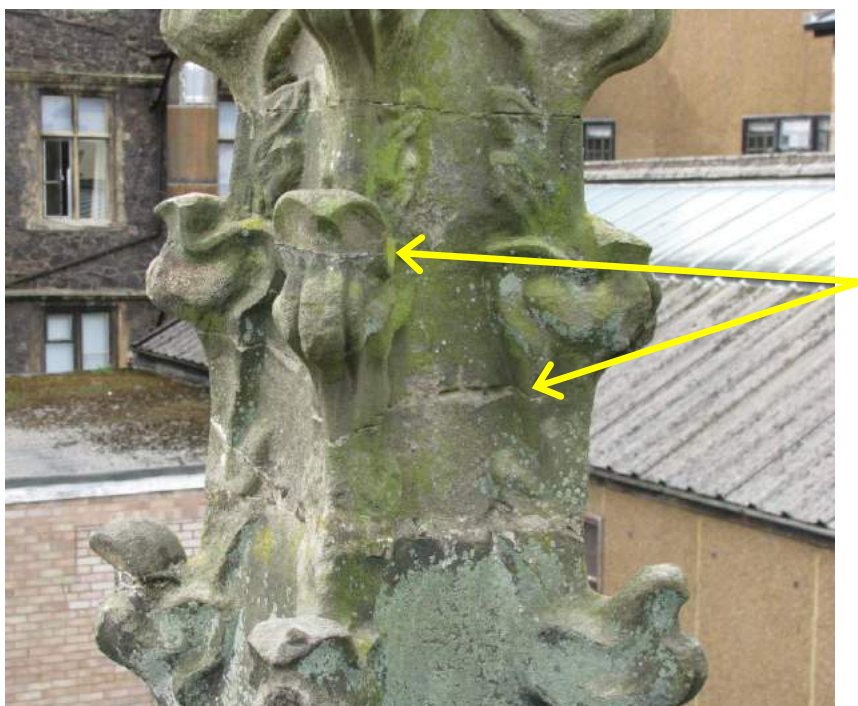
Cracks

The NW (front right) pinnacle bore cracks as shown in figure 23. The pinnacle was taken down and rebuilt as shown in figure 24 with a s/steel bar through its centre. (At this point the pinnacle had been cleaned with the ThermaTech but not with the VorTech machine.)

Figure 23: the NW pinnacle before cleaning and repair.

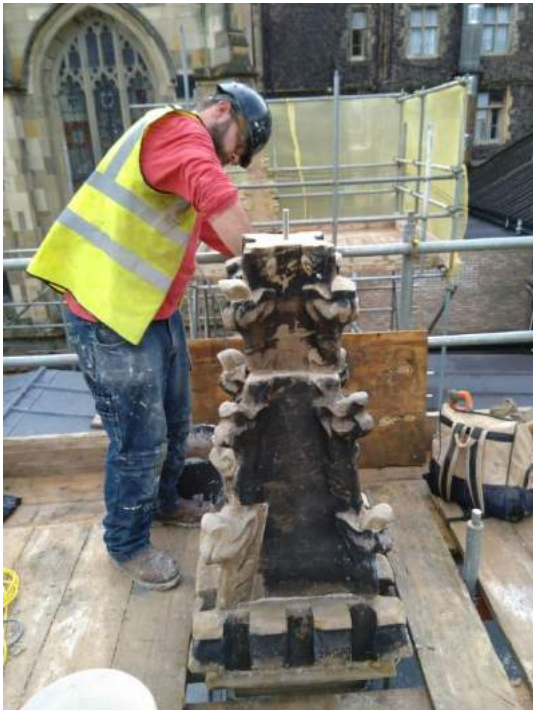
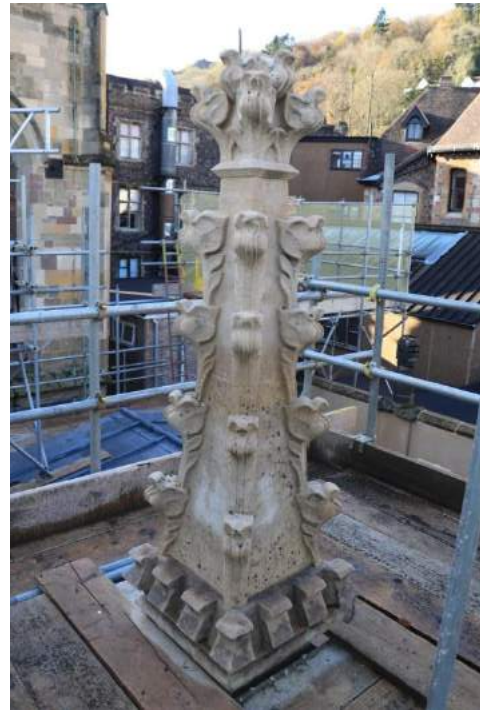
*Figure 24: Left - The NW pinnacle being rebuilt (before VorTech cleaning).
Right – A pinnacle after VorTech cleaning.*

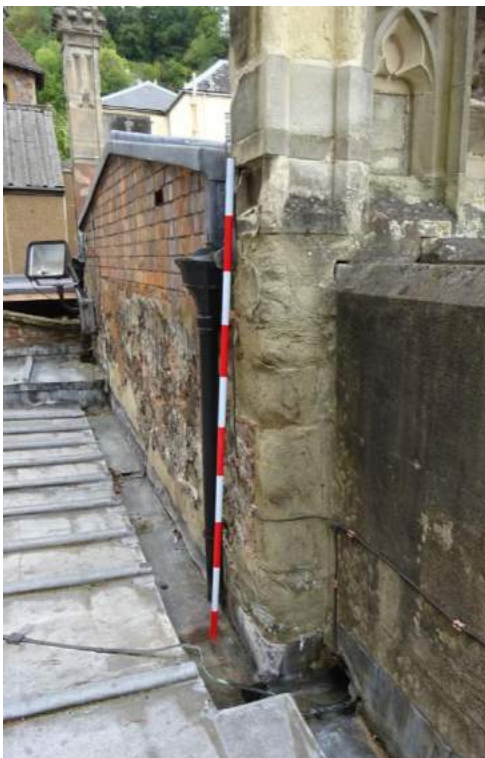
The SE (rear left) pinnacle also needed rebuilding because a stone at the base of the parapet bearing the pinnacle was severely eroded and much of it had fallen away. This stone can be seen by the top of the red and white pole in figure 25. Four new stones were carved to replace this and the three stones immediately above, as shown in figure 26.

Figure 25 (left): Eroded stone at the base of the parapet under the SE pinnacle.

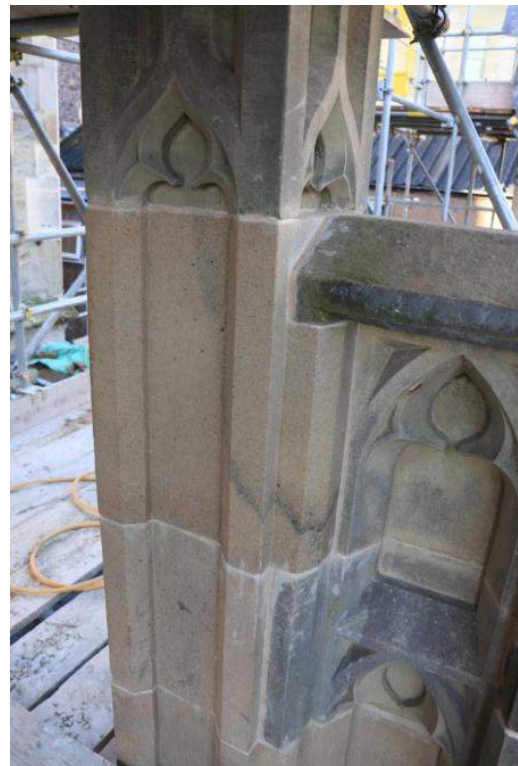
Figure 26 (right): 3 of the 4 new stones in the parapet below the SE pinnacle (the 4th is below the scaffolding deck).

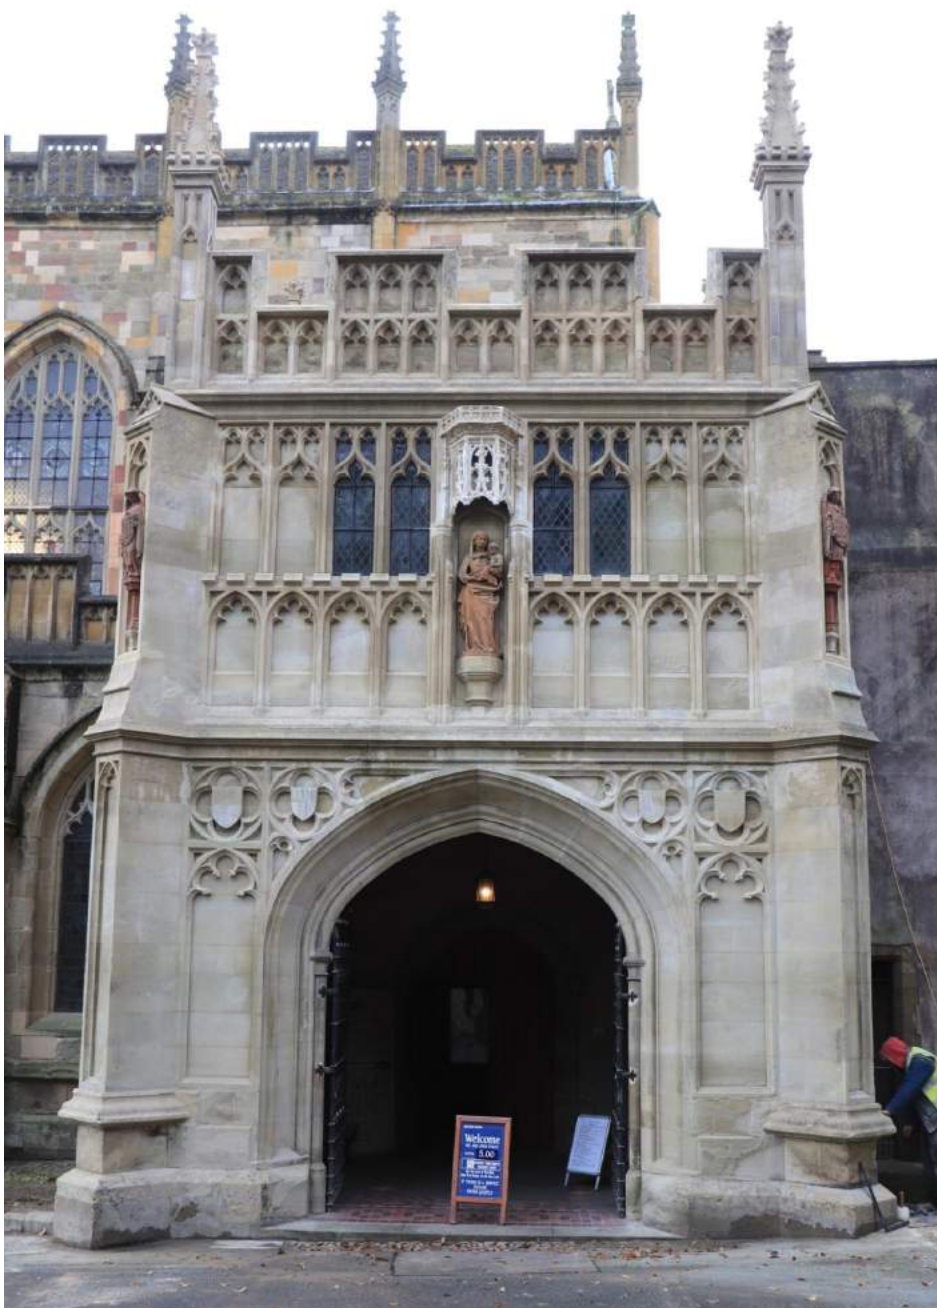
The cleaned and repaired Porch is shown in figure 27. It now provides a bright and arresting entrance to the Priory. The highly ornate canopy has been revealed and can be enjoyed, and the carved detail of the parapet is again legible. The pinnacles are now safe and secure.

Figure 27: The cleaned and restored Porch

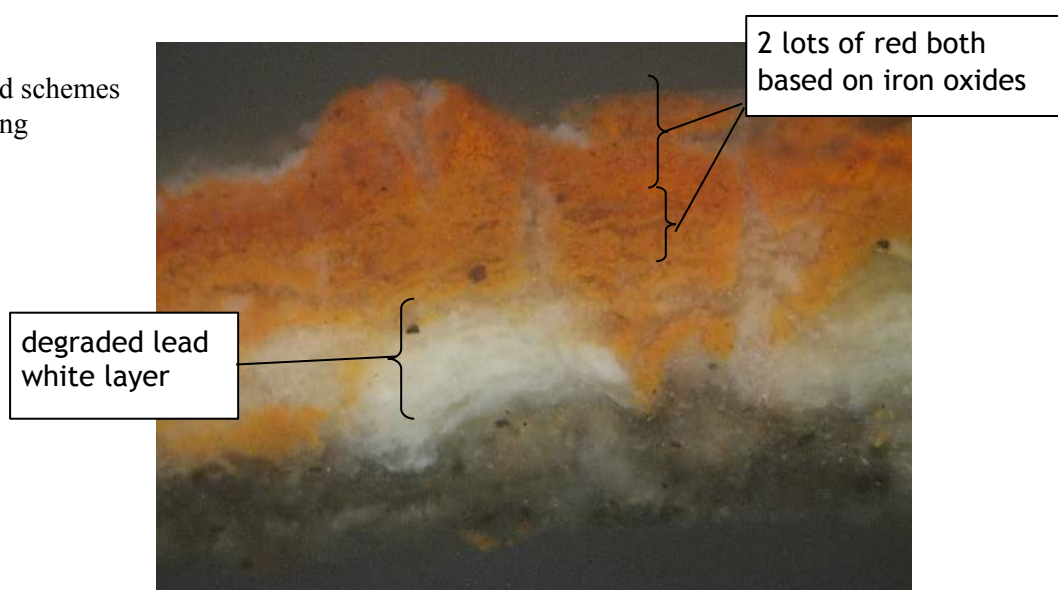
Fragment (i)

Showing how the later red schemes fill cracks in the underlying lead white paint layer

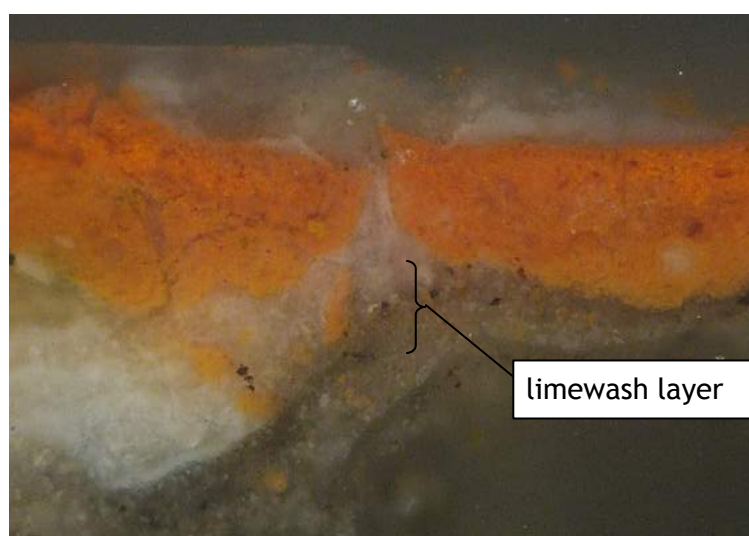
Fragment (ii)

Showing the early limewash more clearly

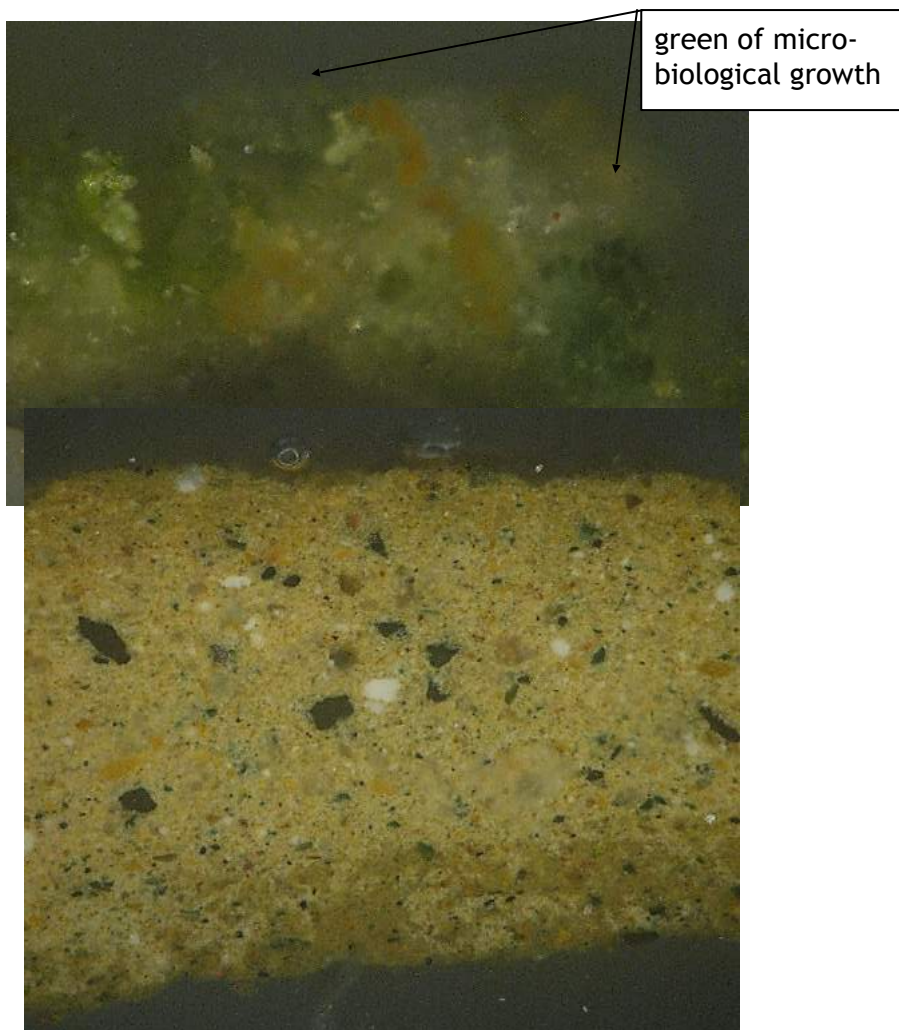
SAMPLE 2

The limewash now looks green because it has been affected by microbiological growth.

Limewash layer containing ochre particles
