Evaluation Report Part A:

Urgent Stonework Repairs at Great Malvern Priory during 2019

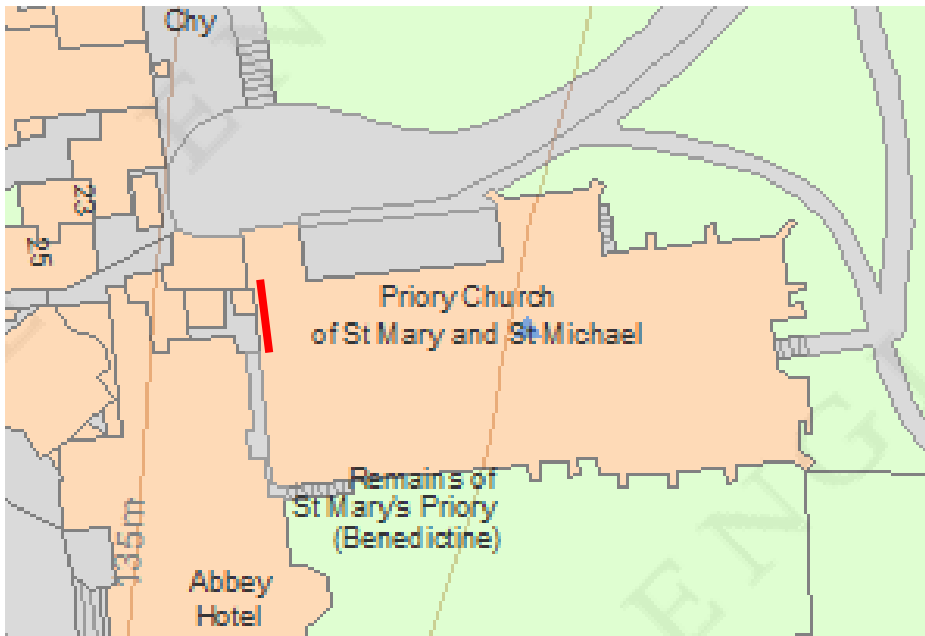
Figure 1: Plan of Priory showing in red the section of the West Wall to be rebuilt

Figure 1 shows a plan of the Priory with the location of the section of west wall to be rebuilt marked in red. Note the very close proximity of the Abbey Hotel behind the Priory.
